# FRACTURE AND FAILURE OF NATURAL BUILDING STONES

Applications in the Restoration  
of Ancient Monuments

STAVROS K. KOURKOULIS

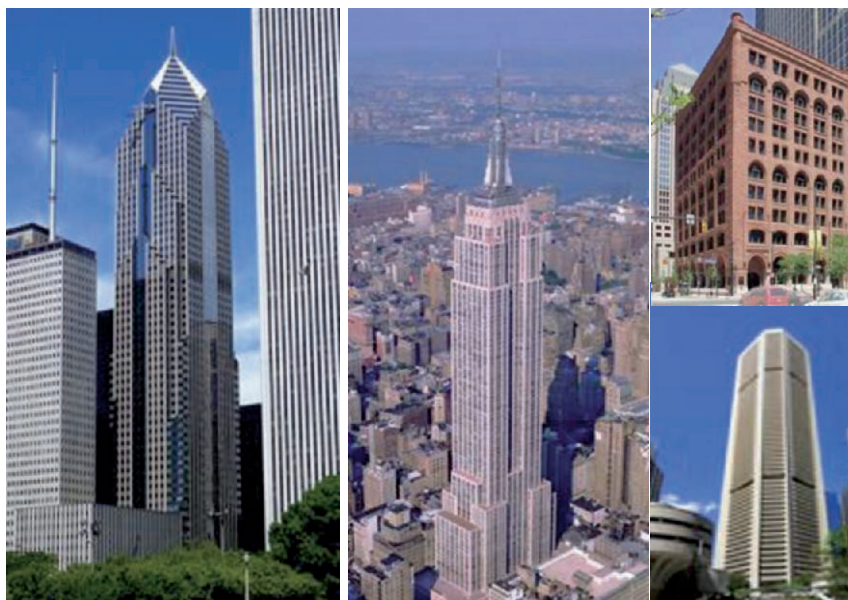
Figure 2. Some famous modern buildings with rock panels on façade, including the Two Prudential Plaza in Chicago, Empire State Building in New York, MLC Center in Sydney, Society for Savings Building in Cleveland.

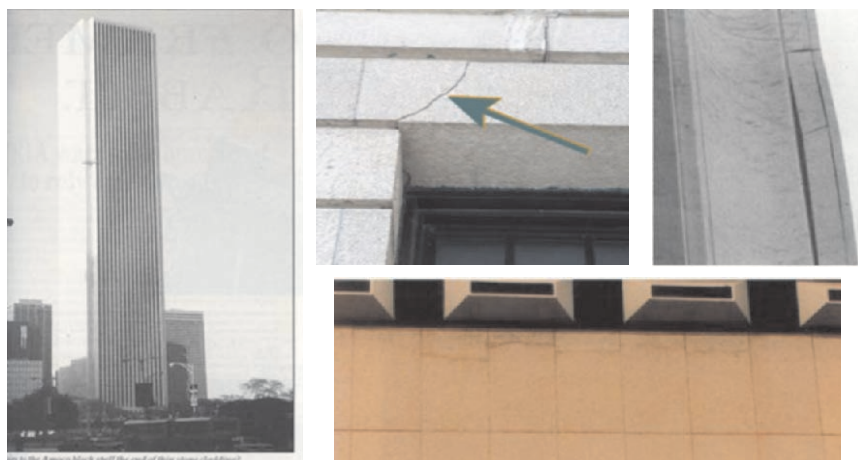
Figure 3. Cracking in the Amoco Building in Chicago and other cracking observed on rock panel cladding.

There have been numerous incidences of rock panel failure reported. One of the most famous rock panel failures is the notable example of 344 m tall Amoco Building (now renamed as Aon Center) in Chicago (Figure 3); and this case was well documented and has aroused international awareness on the safety and problem of cladding wall design (Trehwhitt and Tuchmann, 1988;

Anonymous, 1989; Ridout, 1989; Kent, 1990; Logan et al., 1993; Hook, 1994; Rudnicki, 2000). In 1985 bowing and cracking occurred on some 43,000 slabs of Italian Carrara marble of size  $1.219 \text{ m} \times 0.9144 \text{ m}$  on the external façade of this 80-story building. The marble slabs were completely replaced by granite slabs and the renovation cost in 1991 was US\$ 80 millions, which is about half of the total cost of the whole building about 20 years ago. There are numerous examples of problematic façade rock panels, including the cases of Finlandia Hall in Helsinki (repairing cost of 4 millions Euros in 2000) (Royer-Carfagni, 1999a-b), and Lincoln First Tower in Rochester, New York (repairing cost of 20 million US\$, in 1988). In Hong Kong, serious spalling and cracking appeared at the granite cladding to the 23-story Bank of East Asia Head-quarter building at Central in 1993, ten years after the building was completed. To prevent the granite slabs from falling off and endangering pedestrians, the Bank replaced the entire cladding at a cost of about HK\$ 38 millions. The lawsuit of the Bank against the Architect and Sub-Consultant went all the way to the Court of Final Appeal in Hong Kong. Other examples of cracking problems in cladding can be found in the textbooks by Winkler (1975, 1994). For more information and potential problems on the use of dimensional stone in structures, the readers are referred to Winkle (1975, 1994), Lewis (1995), Franzini (1995), Chew et al. (1998), Smith (1999), Chacon (1999), Gauri and Bandyopadhyay (1999), and Bradley (2001).

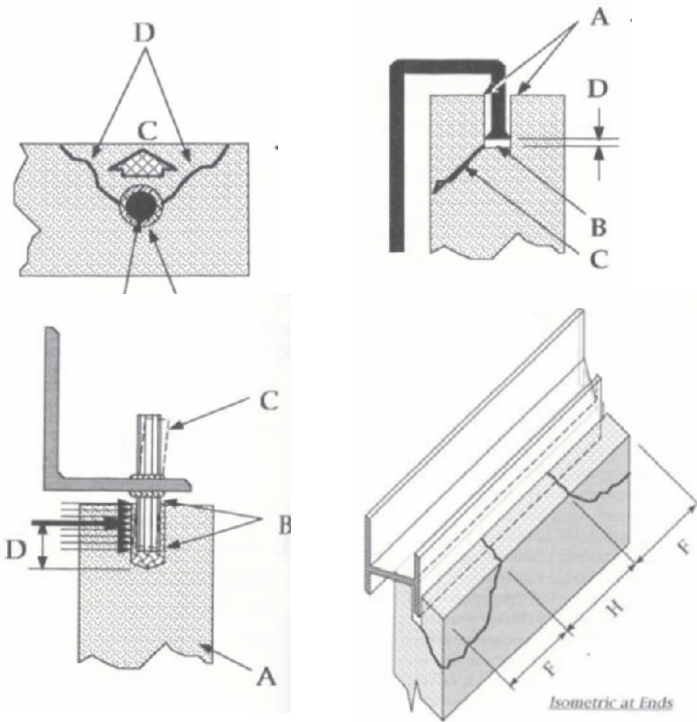
Figure 4. Some cracking patterns emerging from different anchor system of rock panels.

The anchoring system used for holding the stones is also of vital importance to the stability and cracking of rock panels, but no standardized anchoring system design has been adopted internationally. Each supplier has its own design details and concept for the anchoring system. Figure 4 shows some of the potential cracking related to different anchor systems. The main consideration for the design of anchors depends on the ability to resist wind

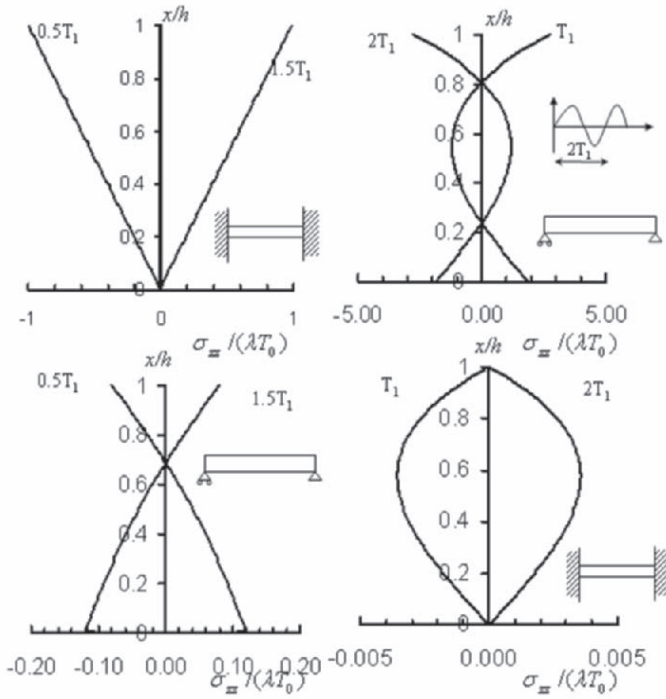
Figure 7. Stress distribution at various time for both fixed and simply support conditions.

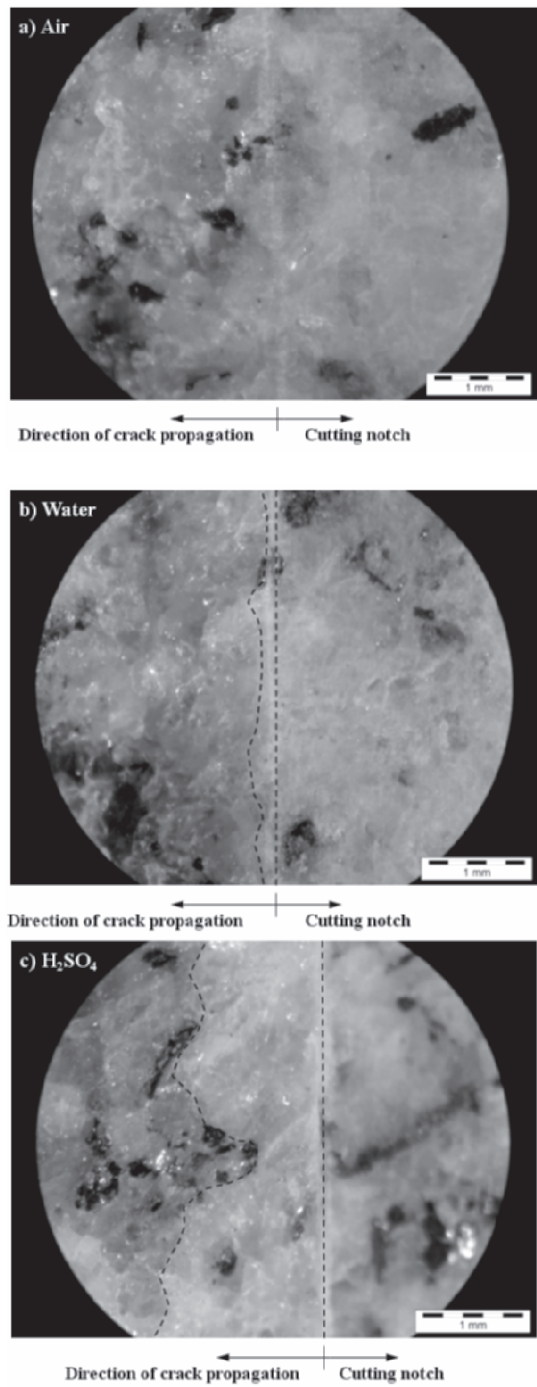
*Figure 14.* The crack tip of granite specimen after four-point bending test in a) air condition, b) water condition (pH=7), and c) H<sub>2</sub>SO<sub>4</sub> (pH=2). Dotted region shows the weathering zone (Kaolinite) of granite specimen.

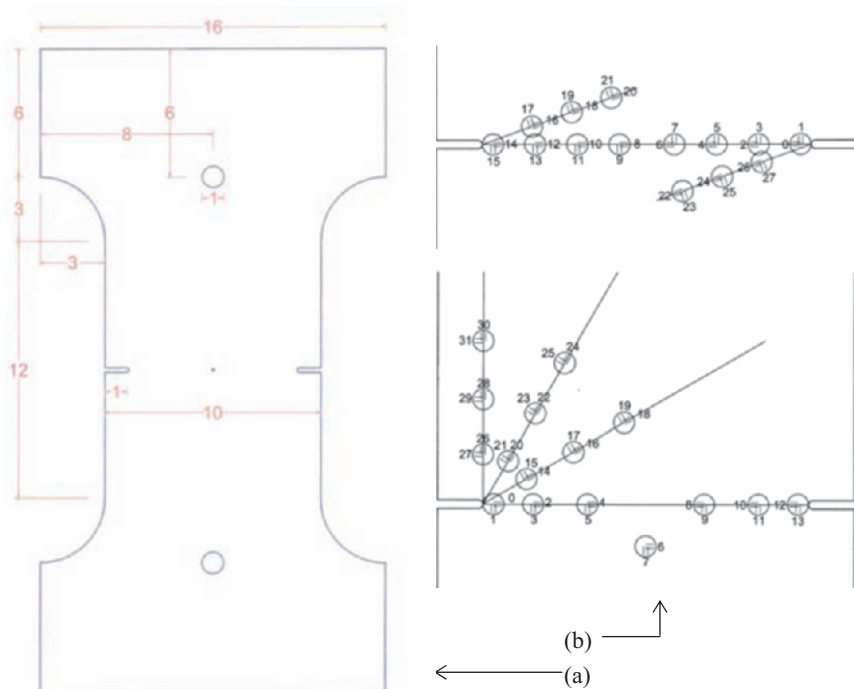
Figure 3. (a) The geometry of the second class of specimens. (b) Detailed view of the two different arrangements of the strain gauges. The dimensions are in cm.

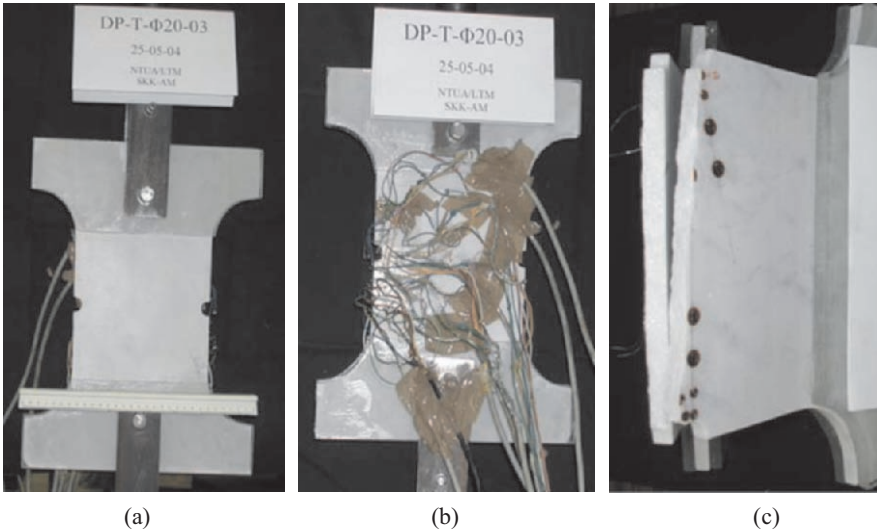
Figure 4. (a) The front and (b) the rear view of a typical specimen with semi-circular notches just before being tested. (c) The fracture surfaces of a fractured specimen.

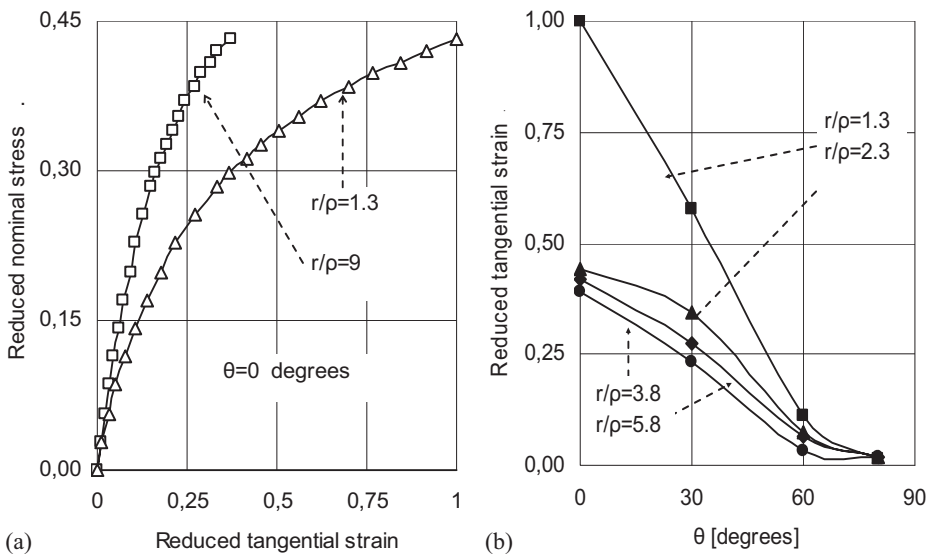
Figure 6. (a) The variation of the transverse strain vs. the remote nominal stress for the central point of the specimen and the point just ahead the notch tip. (b) The polar distribution of the transverse strain along four semi-cyclic contours with  $r/\rho = 1.3, 2.3, 3.8$  and  $5.8$ .

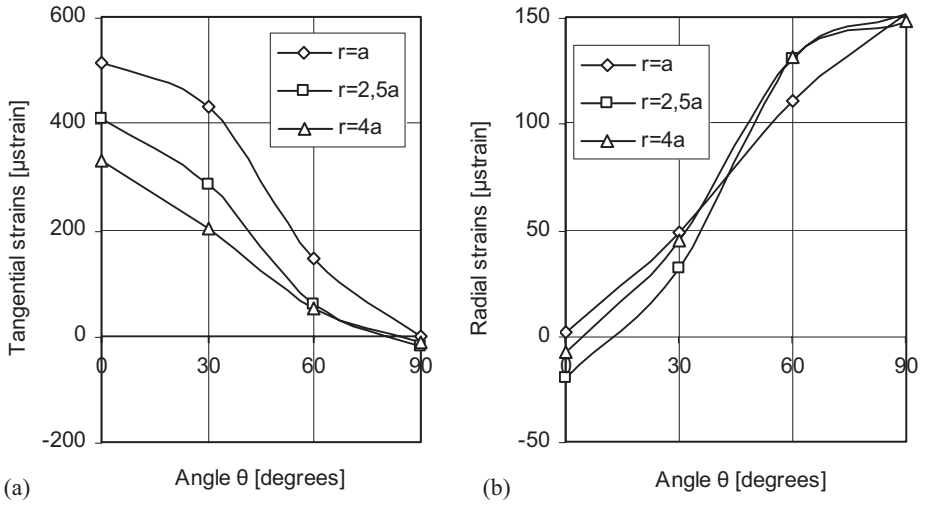
Figure 9. The polar distribution of the tangential (a) and the radial (b) strains for three semi-circular paths around the crown of the notch just before the fracture of the specimen.

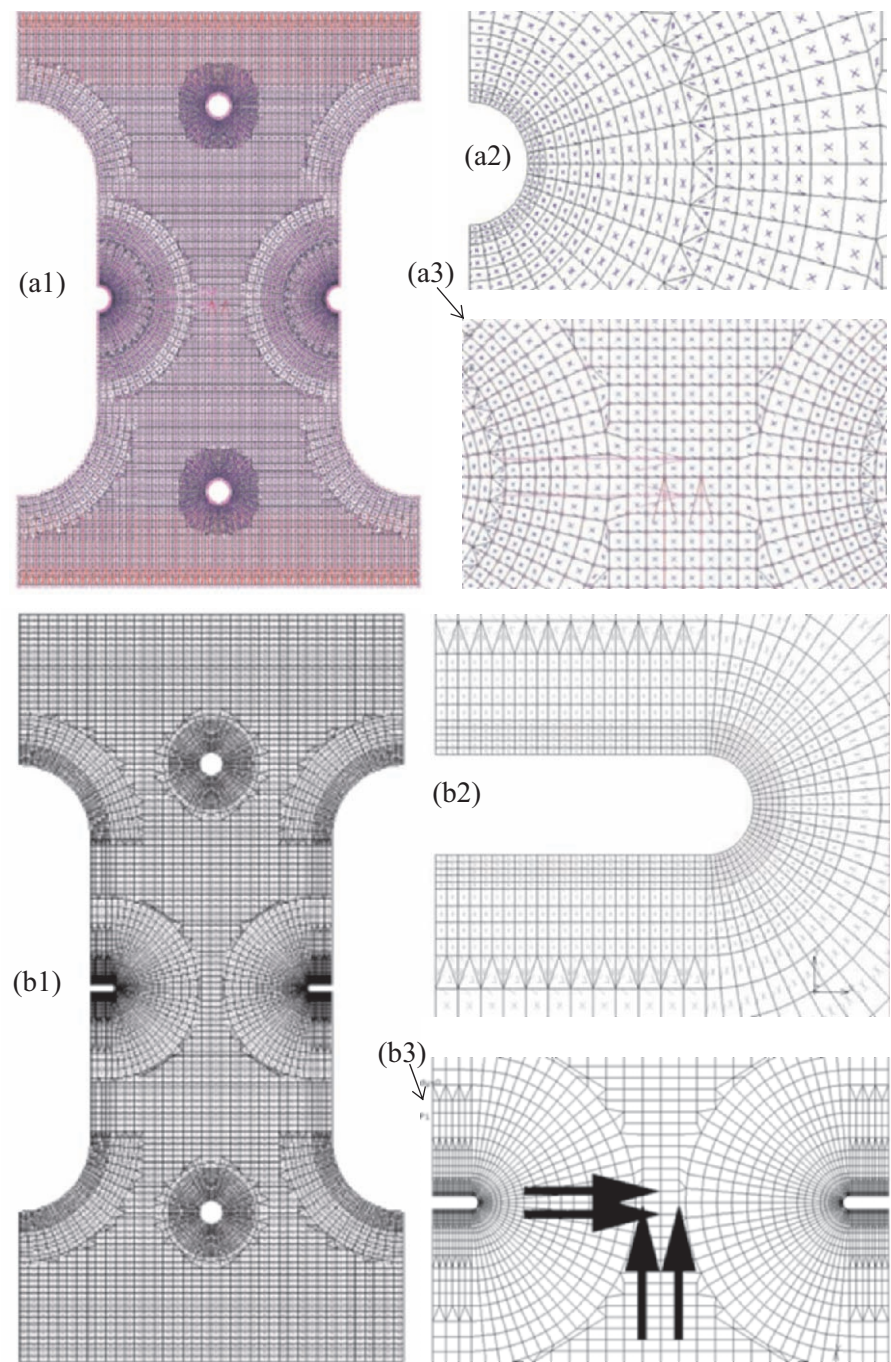
Figure 10. An overview of the numerical models of the specimens with semi-circular (a1) and U-shaped notches (b1). Details of the meshing around the crowns of the notches are also shown (a2, b2) together with the boundary conditions applied (a3, b3).

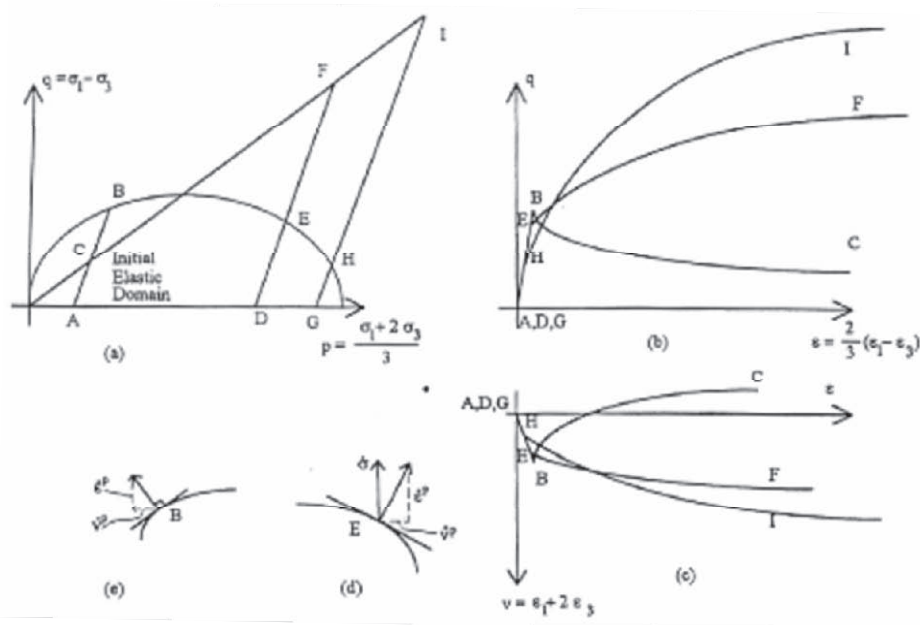
Figure 4. Schematic picture of the Cam Clay model: (a) stress paths in constant cell pressure tests with different overconsolidation ratios; (b) stress-strain behaviour; (c) volumetric strains; (d), (e) normality rule for different stress states.

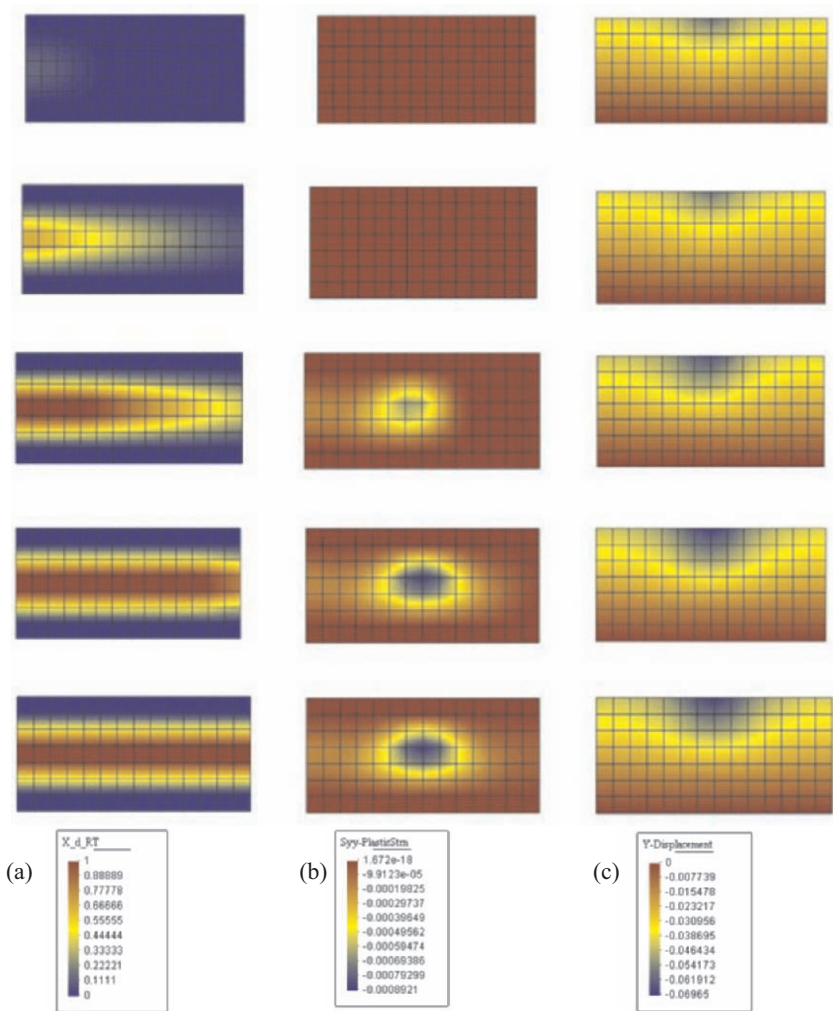
Figure 12. Effects of the diffusion of a contaminant under a shallow foundation; (a) Variation of  $x_d$ ; (b) Deviatoric plastic strains; (c) Vertical displacements for successive time steps (Parma, 2004).

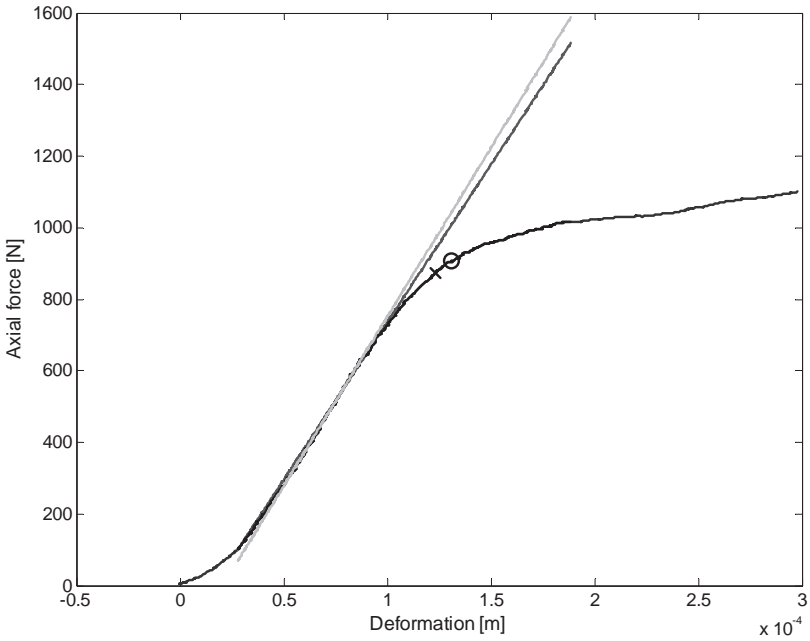
Figure 14. Indentation force versus indentation depth in a typical indentation test on Dionysos marble. The black cross is the *CTS* calculated with a predefined deviation equal to 60% and the black circle is the *CTS* calculated from the curve's minimum of the double derivative.

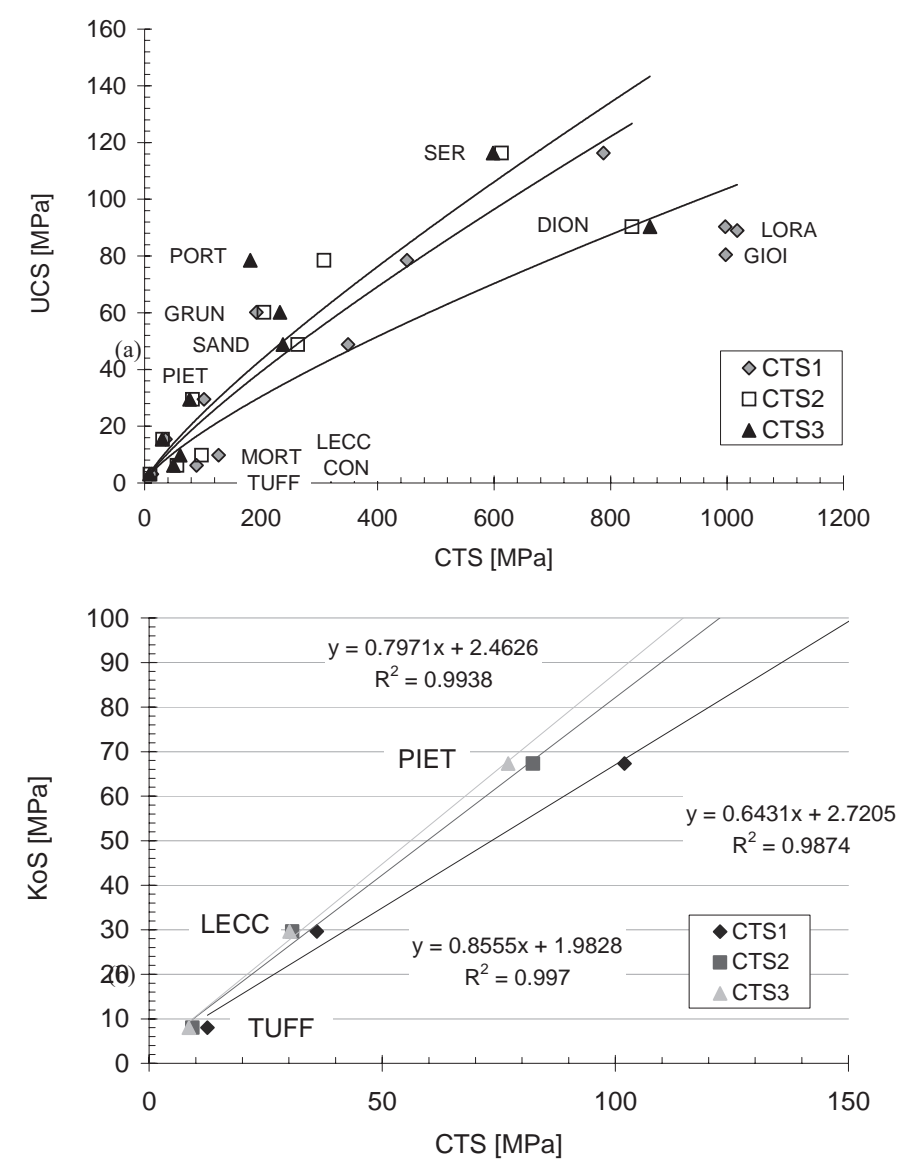
Figure 15. Correlations between (a) UCS, and (b) Uniaxial compaction stress  $K_\rho S$ , and Critical Transition Stress CTS for indenter diameter 1-mm (CTS1), 2-mm (CTS2) and 3-mm (CTS3).

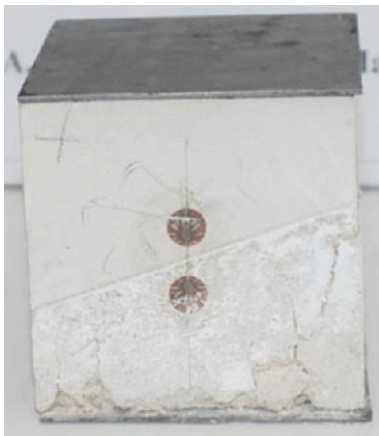
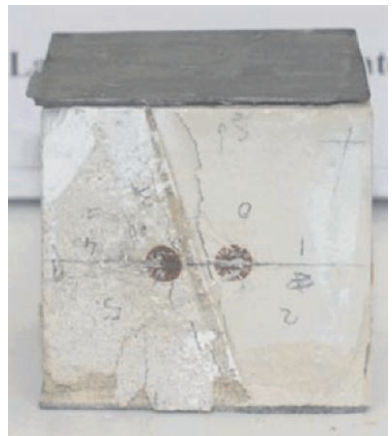
*Figure 4.* Typical tested composite specimens. (a)  $\theta=15^\circ$ . The failure of the original stone (lower part of the specimen) is clearly visible. The substitute material is intact. (b)  $\theta=75^\circ$ . The failure started from the substitute material (right part of the specimen) very close to the interface. The original material remained almost intact. (Thin lead plates between the specimen and the loading plates ensured optimum contact in both cases).

The quantities measured during the tests were the load, the axial displacements from the LVDTs and the strain components from the strain gauges. Processing properly these data using commercially available software for the elimination of experimental noise and the rejection of statistically unacceptable tests, the overall axial stress - axial strain diagrams were obtained. Successive photographs taken during the experimental process ensured that one could detect the exact moment of appearance of surface cracks, exfoliations or other failure phenomena in order to decide on which of the two materials failed first. Typical composite specimens are shown in Figure 4, after they have been tested. Various failure types can be clearly seen.

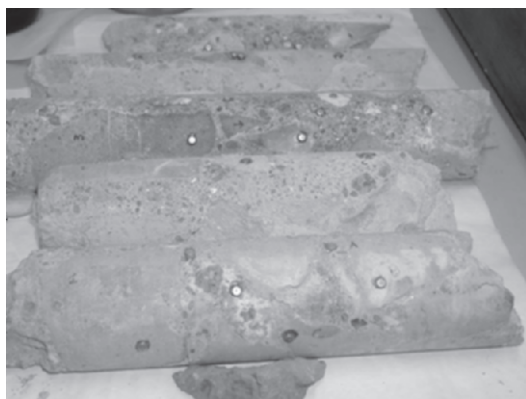
Figure 4. The core samples used for wetting-drying cycles, showing large pieces of aggregates, typical of the roman opus caementicium.

Three couples of metallic datum-points were applied on all cores in various points in order to obtain three different measures in each sample (Figure 4). Each sample was longitudinally immersed in tap water covering only half of its diameter to damp gradually the total core by capillary rise and to allow the entrapped air to escape. A series of measurements were taken at regular periods for a month or more. Afterwards, the wet samples were left in open air in the laboratory for a month or more until they were dry. Six complete wetting-drying cycles were carried out on each sample.

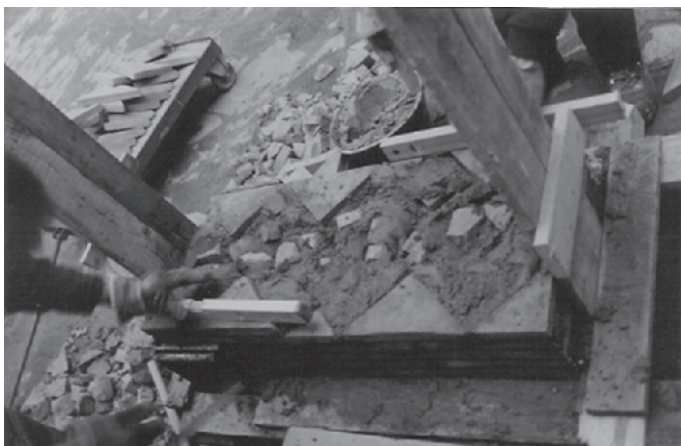
Figure 8. An example of roman – type wall during the preparation in the laboratory (Engineering Faculty, University of Rome “La Sapienza”).

The purpose of the last phase of the work was to test panels representing portions of the whole Roman wall, composed of two external layers of bricks containing the core of opus caementicium (Figure 8). The triangular bricks were handmade, in order to obtain a strength (average  $19.3 \text{ N/mm}^2$ ) similar to that of the original bricks. The filling of the core followed the procedure suggested by a number of authors (Adam 1984, Giuliani 1990). The wall samples were built on steel plates in order to move them from the building site to the testing machines. Two of the samples were subjected to axial compression. The most significant results are the following:

- the ultimate average strength is  $6.3 \text{ N/mm}^2$ .
- the wall samples follow good linear behaviour up to around  $5 \text{ N/mm}^2$ .
- the collapse is preceded (at around  $4.5 \text{ N/mm}^2$ ) by vertical (columnar) cracking. The Poisson's ratio in the elastic region increases from its initial value of 0.18 to more than 1 near collapse.

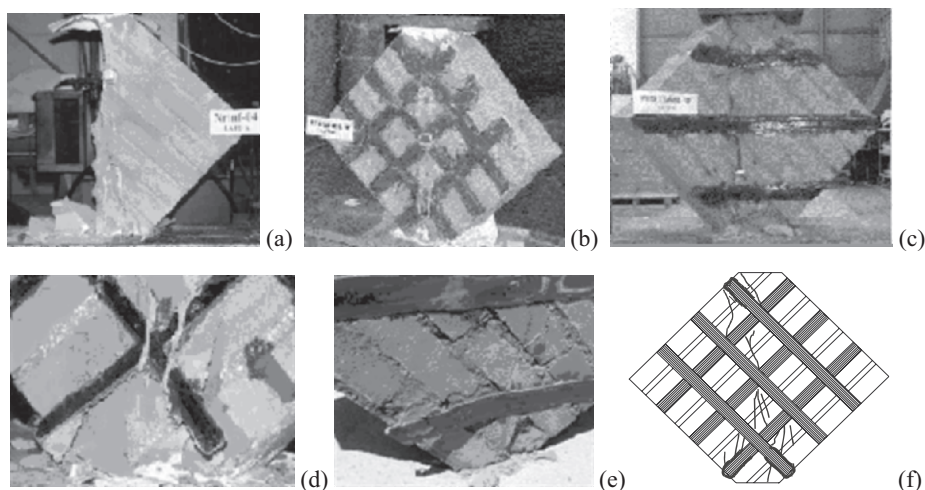
Figure 15. Mode of failure of the panels under diagonal loads: (a) reference panel (unstrengthened); (b) (c) one-side strengthened panels: (b) grid pattern, (c) diagonal pattern; double-side strengthened panels: detail of the peeling in the anchoring zone on grid (d) and diagonal (e) pattern; (f) crack distribution on grid pattern.

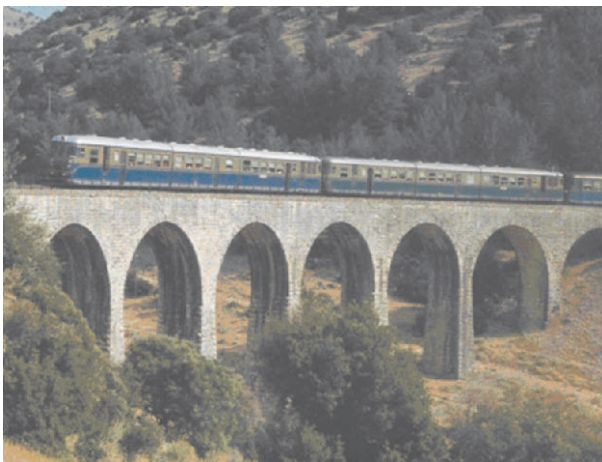
Figure 2. Masonry arch railway bridge in Manari, Greece.

In order to perform the analysis of the masonry bridge a model was formulated using solid FE elements, so as to acquire detailed out-of-plane stress and failure results in case of an earthquake event. Eight and six isoparametric

solid elements were implemented, activating three translational degrees of freedom. Masonry was considered isotropic. The macro-analysis model is shown in Figure 3.

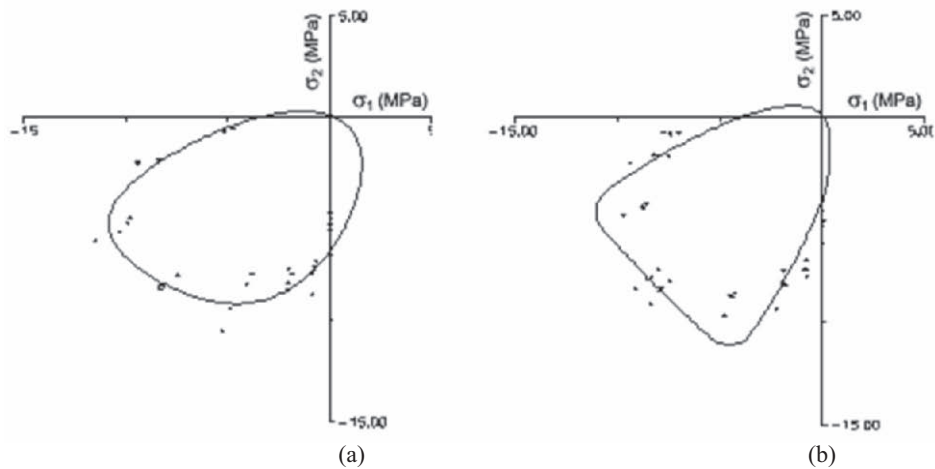
Figure 7. Masonry failure criterion in principal stress terms: a)  $q=22.5^\circ$ , b)  $q=45.0^\circ$ .

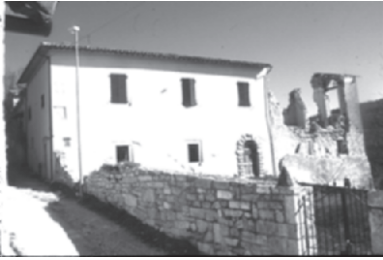
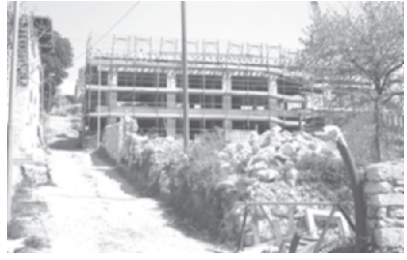
Figure 3. The building repaired in the 80s and partially failed, has been demolished and an r.c. structure rebuilt.

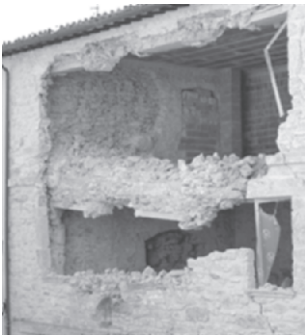
Figure 6. Out-of-plane collapse of a wall with r.c. tie beams.

The collapse mechanism of the masonry is not for in plane shear as expected after the floor substitution, but a partial overturning mechanism of the external leaf of the wall which starts for lower values of the expected collapse coefficient. Some details visible in the upper part of the Figures 4 and 6 suggest that the intervention contributed to reduce the already weak connection between the leaves to the very critical section where the walls are connected to the floor. In fact, in those connections the confining actions of the floors are applied and most probably less uniformly distributed. Even the contribution of the new internal wall (Figure 6), perpendicular to the collapsed facade was completely missing in the collapse, possibly due to the restoration interventions.

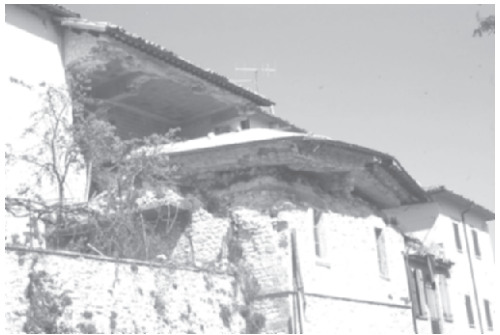
Figure 7. Roof hammering the masonry walls.

In this technique it is important to realise an effective connection between the tie beam and the masonry. In the case of the tie beam at the roof level, which can rest on the whole section of the wall, the connection is difficult because it should be realised by vertical metal connectors inserted in the wall from the top. Once again, this connection is seldom possible in a multiple leaf stone masonry. Furthermore the stiffness of the concrete roof can be too high compared to the one of the existing wall and the roof can hammer the wall and cause a partial collapse (Figure 7).

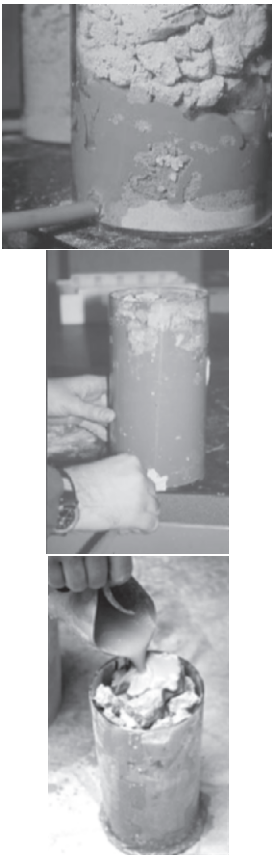
Figure 15. Phases of the injection in laboratory.

Injectability tests can be carried out directly on site on sampled area, locally dismantling the masonry. Non destructive tests as sonic tests can also be carried out on site, before and after injection in order to detect the penetration and diffusion of the grout.

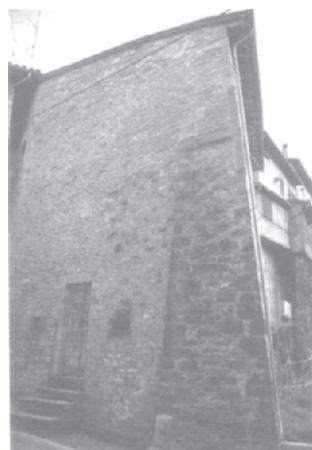
Figure 19. Addition of buttresses

Another system largely adopted in Umbria was the use of buttresses against the existing walls (Figure 19).

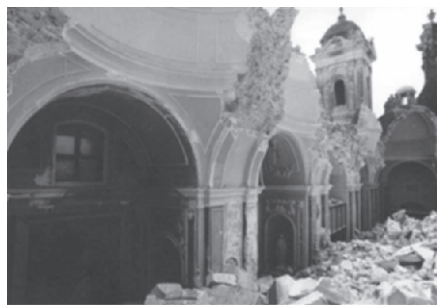
Figure 2. (a) The transversal section and (b) the collapsed Noto Cathedral.

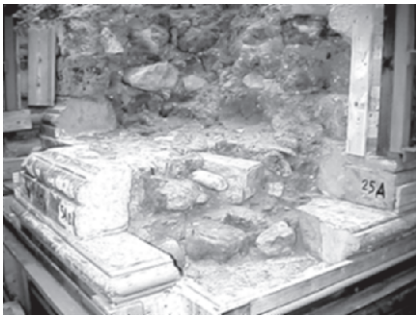
Figure 3. Detail and horizontal reconstruction of a pier section.

The inner part of the pillars represents 55% of the entire section, while it represents 58% in the piers supporting the dome. This part, with irregular by-cut stones up to the half of the total height, was made with large round river pebbles (Figure 3). Nevertheless, every 50 cm a course, made with small stones and mortar, was inserted in order to obtain certain horizontality (Figure 4). Scaffolding holes were left everywhere, some crossing the whole section. The mortar made with lime and a high fraction of very small calcareous aggregates appeared to be very weak. Also, the bond between the mortar and the stones was very weak; in fact, it was possible to sample stones and pebbles from the interior of the pillars without any difficulty and with the stones completely clean of mortar.

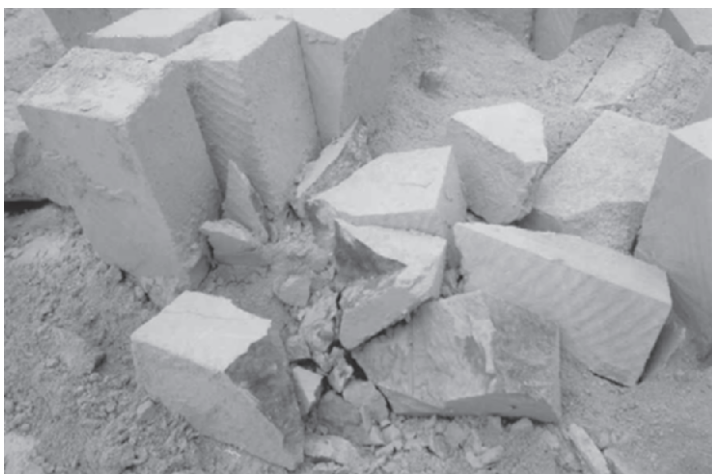
*Figure 13.* Creaked blocks in quarry.

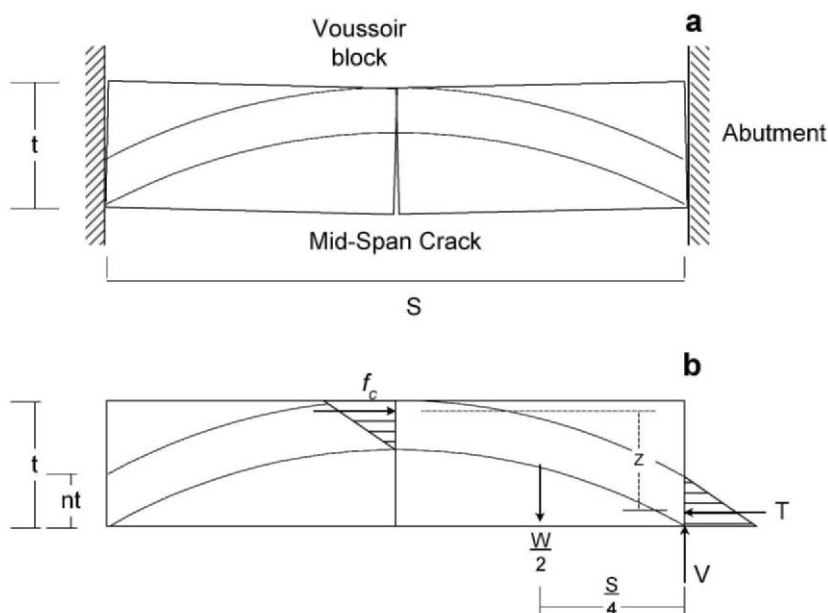
Figure 6. The Voussoir beam analogue (after Brady and Brown<sup>4</sup>).

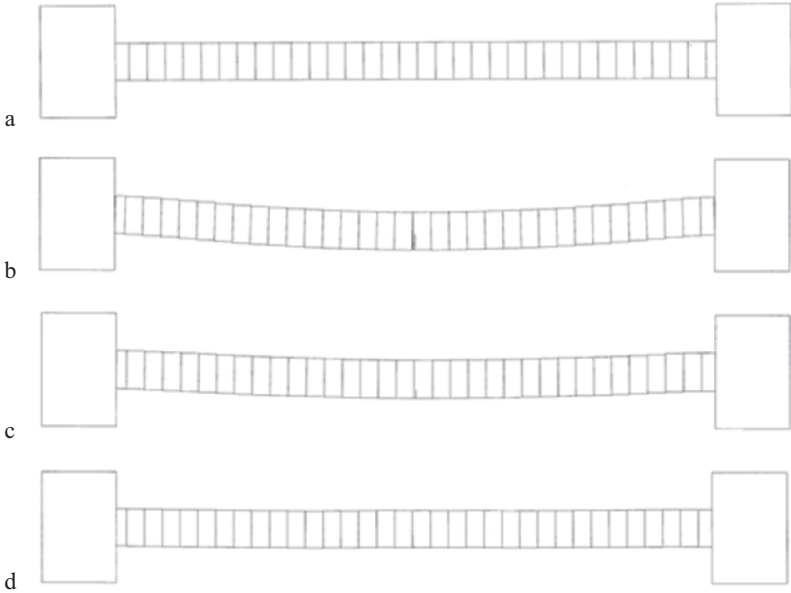
Figure 9. DDA graphic output of single layer deformation for different values of joint friction angle: (a) original geometry; (b)  $\phi_{av} = 45^\circ$ ; (c)  $\phi_{av} = 75^\circ$ ; (d)  $\phi_{av} = 80^\circ$ .

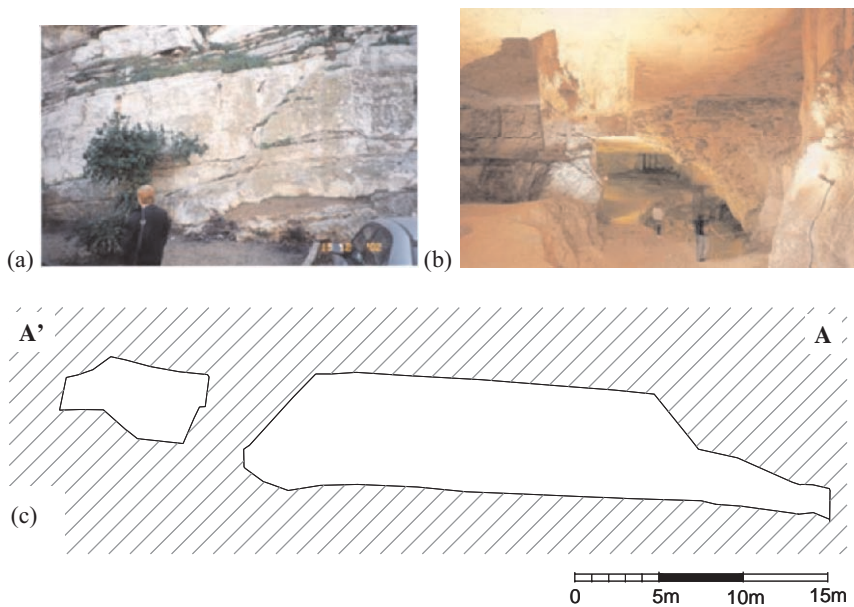
Figure 14. (a) The Bina formation outside Zedekiah cave, (b) A view towards Freemasons hall (Photograph by Y. Novitz<sup>13</sup>), (c) A cross section through Freemasons hall (for location see Figure 13b).

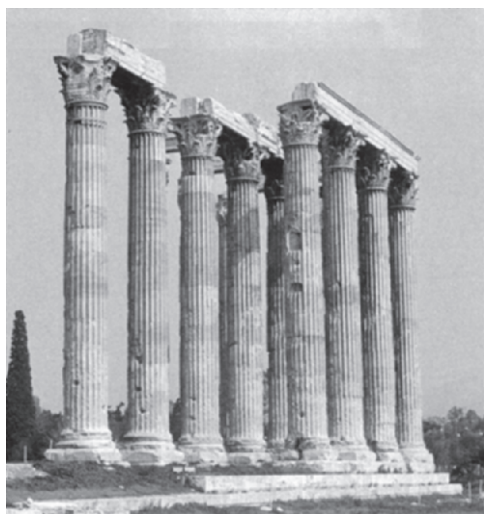
(a)

In the present condition of the monument, most drums of the columns are displaced by a few millimeters from their original position, especially close to the top. However, the most severe damage concerns a crack close to the middle of the span of the architrave and a clear almost vertical crack at drum #14 of column 7.6, right underneath the capital.

The height of each drum is not constant, depending on the pieces of marble available at the site during the construction. Also, the number of drums varies from column to column. Thus, column 7.5 has 15 drums and column 7.6 has 14 drums. The drums are connected to each other by two steel dowels (randomly placed in the direction N-S or E-W) with a cross section varying from 9 to 14 cm<sup>2</sup> and a length of about 12-14 cm (data supplied by M. Korres). Originally, connections also existed between the architrave beams which, in most cases, are missing today.

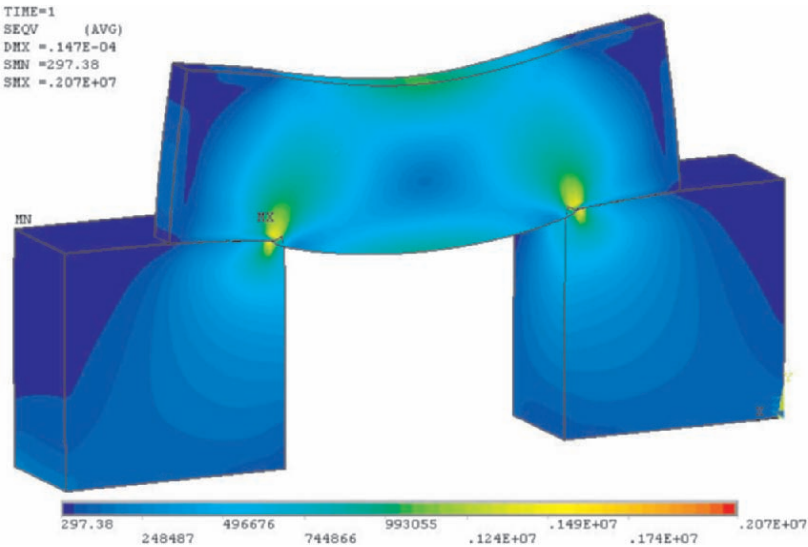
Figure 3. The distribution of the von Mises equivalent stress for the maximum load expected.

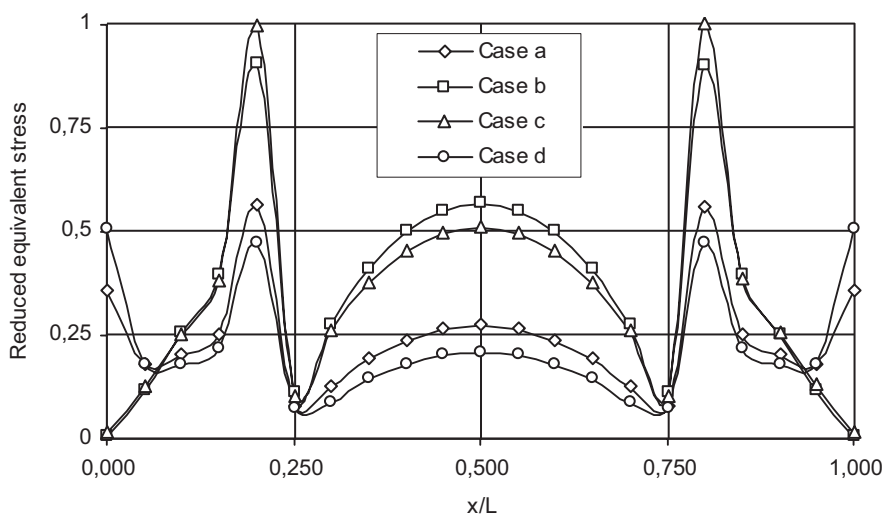
Figure 4. The equivalent von Mises stress along the bottom central longitudinal line of the architrave for the four loading cases. The distance is reduced over the length,  $L$ , of the architrave while the stress is reduced over the maximum value developed.

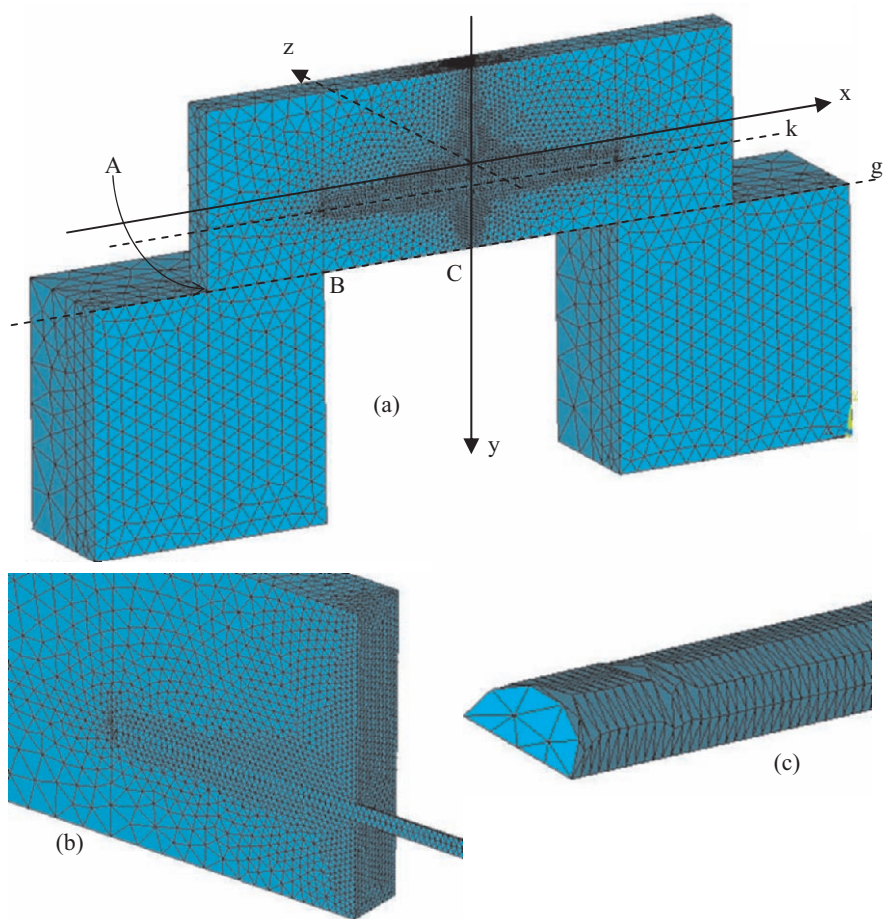
Figure 6. (a) An overall view of the model in the case of a fractured and restored architrave. (b) Detailed view of the mesh in the region of the titanium bar. (c) The mesh of the bar.

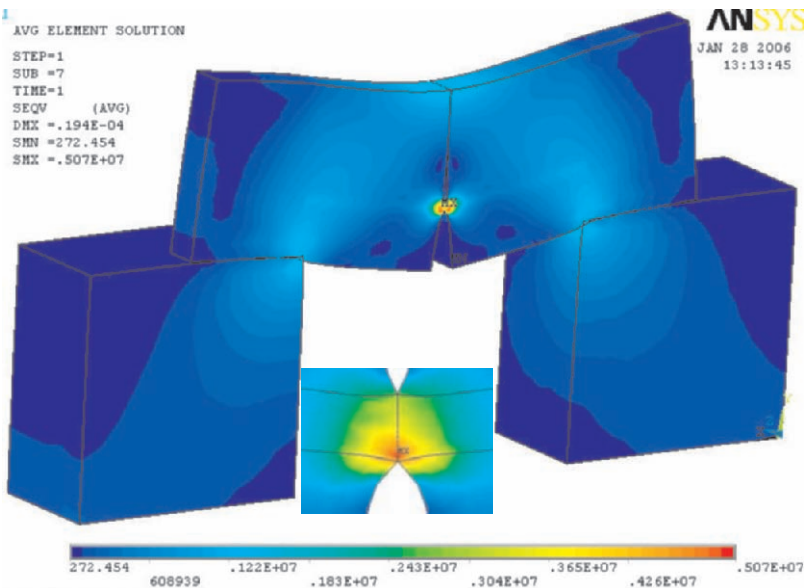
Figure 7. The distribution of the equivalent stress in the restored architrave. The embedded figure shows a detail of the central section around the titanium bar.

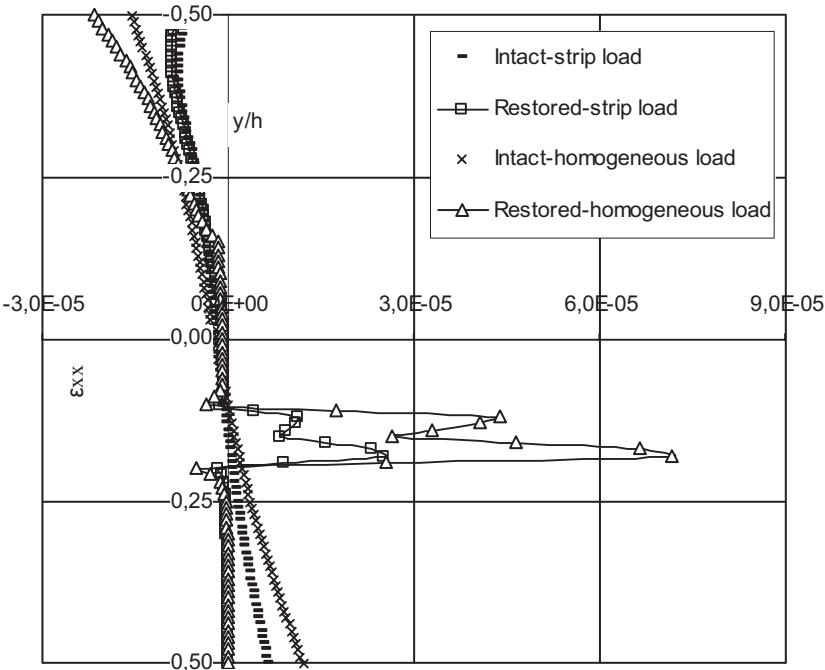
Figure 13. The variation of the axial strain,  $\epsilon_{xx}$ , along the height of the central cross section for both the intact and the restored architrave for uniform load and eight-point bending.

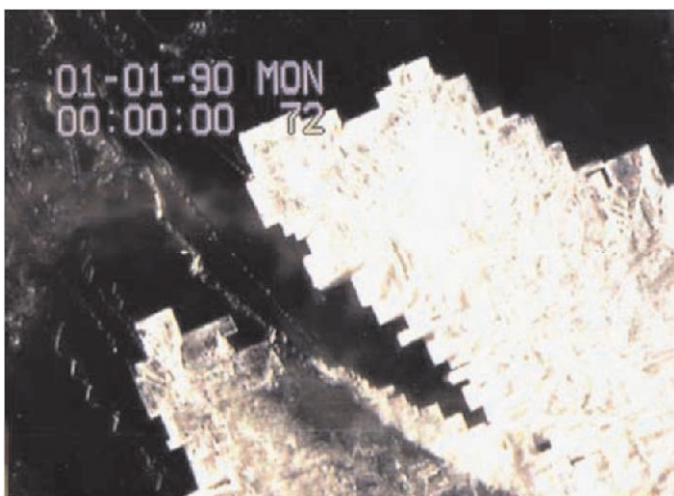
Figure 3. Thenardite ( $\text{Na}_2\text{SO}_4$ ) crystals grown on the coating of PAA-VLMW on calcite.

To evaluate the interaction between the organic coating and a growing salt crystal, a drop of solution was allowed to dry on the surface of a single crystal of calcite, then a drop of sodium sulfate solution was placed on the polymer and allowed to dry at room temperature. The contact angle of the solution was high on the samples treated with polyvinyl alcohol, hexadecane sulfonic acid and TP; the angle was intermediate on phenylvaleric acid, maleic acid, and medium molecular weight polyacrylic acid; the solution spread on Optima 100<sup>TM</sup>, humic acid, and very low molecular weight polyacrylic acid (PAA-VLMW). In most cases, the crystals grew at the boundary of the droplet of solution; only on samples coated with humic acid or PAA-VLMW did the crystals spread across the surface of the polymer coating. The most striking and reproducible result was for PAA-VLMW, for which crystals with a unique morphology spread across the surface (see Figure 3). These crystals remain clear, so they are apparently thenardite ( $\text{Na}_2\text{SO}_4$ ), whereas mirabilite ( $\text{Na}_2\text{SO}_4 \cdot 10\text{H}_2\text{O}$ ) crystals turn white as they dehydrate.

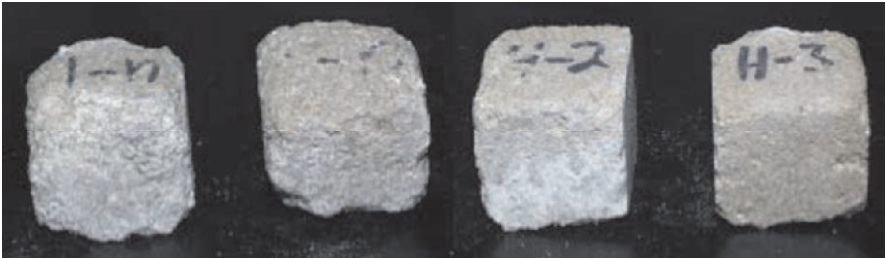
Figure 8. Trial 2 Cycle 16: Untreated stones (left two) and stones treated with PAA-VLMW (right two). Untreated stones begin to round off while the treated stones show only slight deterioration at corners and edges.

The physical appearance of the samples after cycle 16 in Series 2 is shown in Figure 8. The untreated stones are rounded owing to substantial damage on the faces and edges, while samples treated with PAA-VLMW show only minor damage on the edges.

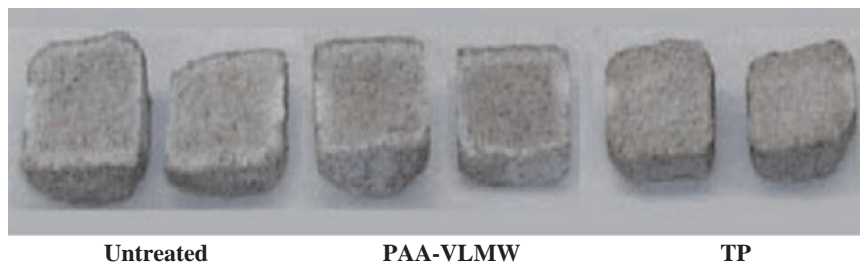
Figure 9. Salt distribution in samples split open after cycle 16 in Series 2. Efflorescence appeared after 10-15 minutes, indicating location of salt. Untreated stone and sample treated with PAA-VLMW has ring of salt within ~1 mm of surface, whereas all salt has retreated to the center of the sample treated with the terpolymer.

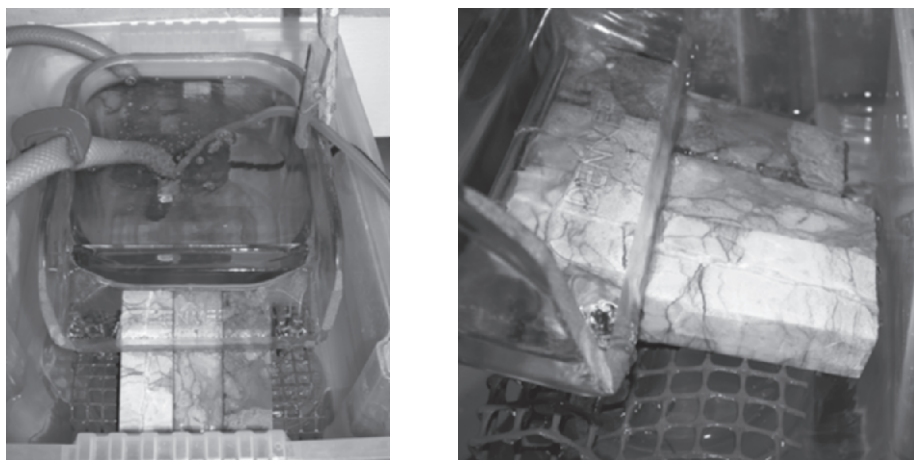
Figure 1. Details of the washout equipment.

The effect of rain washout was simulated by means of an ad-hoc apparatus consisting of two tanks (Figure 1).  $\text{CO}_2$  was bubbled in water in order to enhance the rock dissolution. A film of water, with a flow rate of about 3.5 lt/min, flowed continuously on the surface of the rock samples for a maximum time of  $10^3$  hours.
